Inspection Report Minerals Regulatory Program Report Date October 17, 2005

Mine Name: T&M Holdings

Operator Name: Decorative Landscaping

Permit number: S/035/023

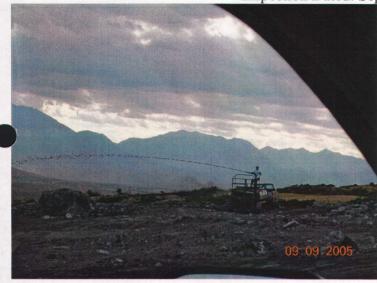
Photo 1.

During the inspection, the operator was in the process of hydroseeding the disturbed area (Photos 1-3). Mr. Burnham said the seed mix was one he found on a web site. Fertilizer (25/5/3) was mixed with the slurry, and, as I recall, it was being applied at the rate of 25 pounds/10000 square feet. They are also watering the area in an attempt to accelerate germination.

In the future, I suggest that the operator not use fertilizer. Best results are usually obtained by applying seed and mulch in two separate operations.
